# **Assessment of Safety Standards of Magnetic Resonance Imaging at the Korle Bu Teaching Hospital (KBTH) in Accra, Ghana**

Samuel Opoku, William Antwi and  
Stephanie Ruby Sarblah

<http://dx.doi.org/10.5772/52699>

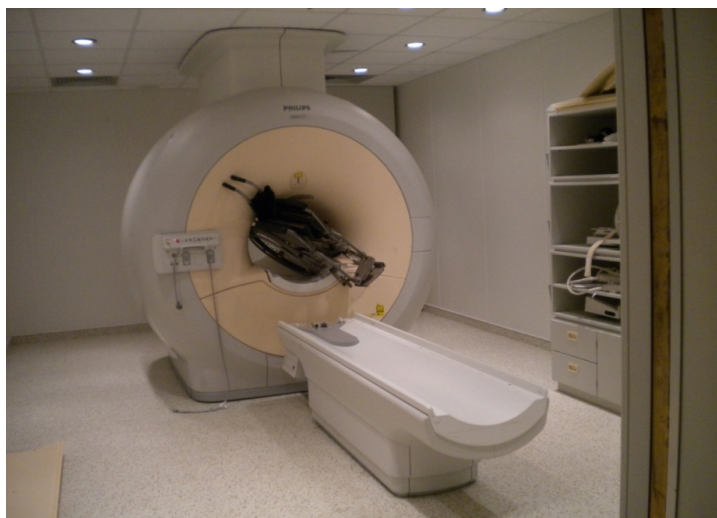
Figure 2.

A photograph of the wheelchair that got trapped in the gantry of the MRI Scanner on the 12<sup>th</sup> of May, 2010 at the Korle Bu Teaching Hospital, Accra. Ghana

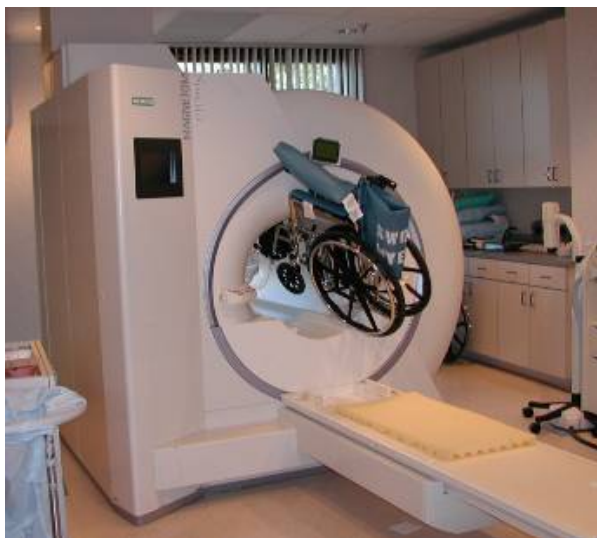
Figure 3.

### MRI Incidents in different parts of the World
